## Windstorm Mitigation Report (OIR-B1-1802)

Chateaux Versailles Condominium Association, Inc.

2275 62nd Ave N, Building 4, Units 101-204

As of 02-04-2025 | FPAT File# MUD2523692

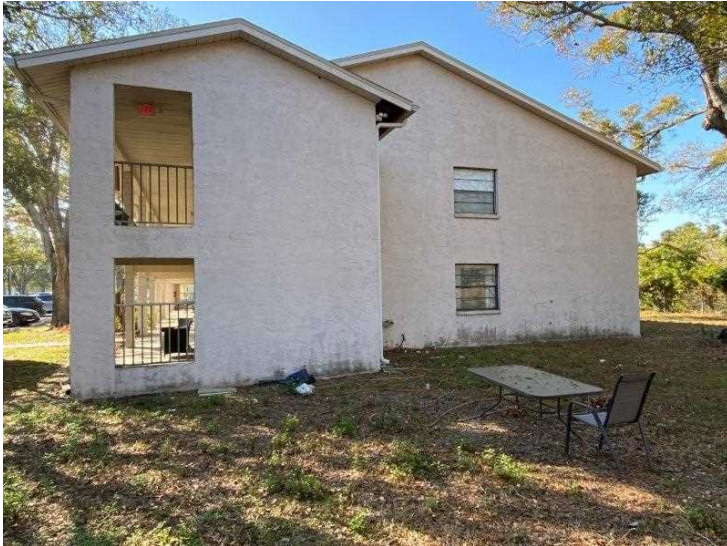
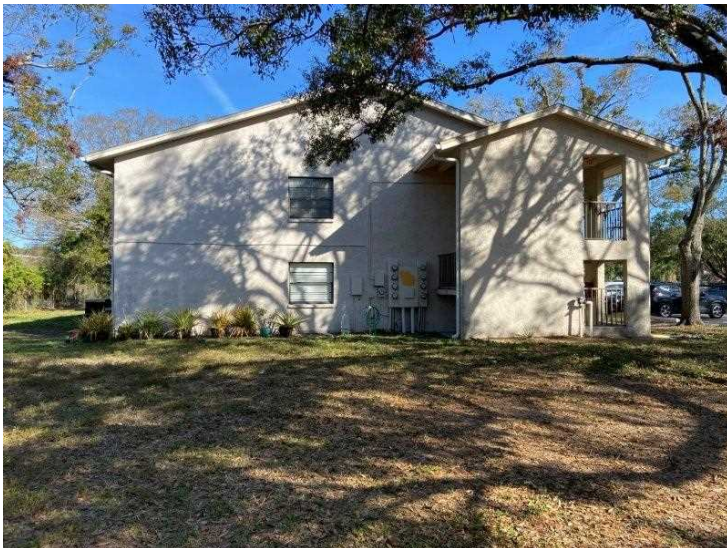
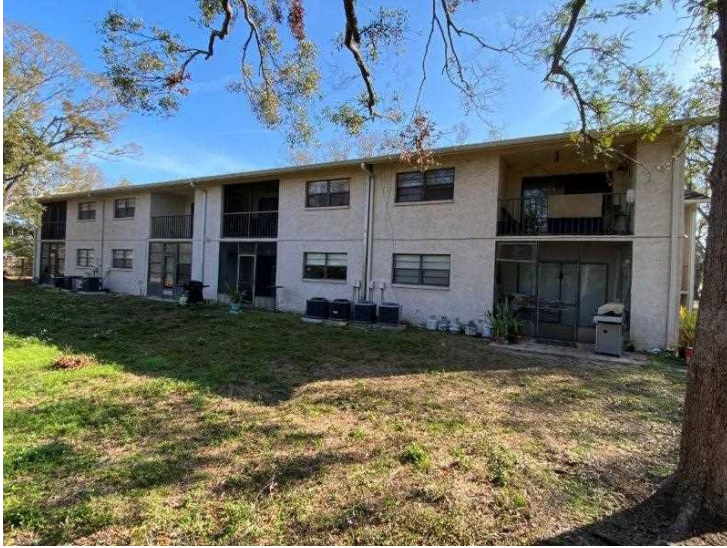
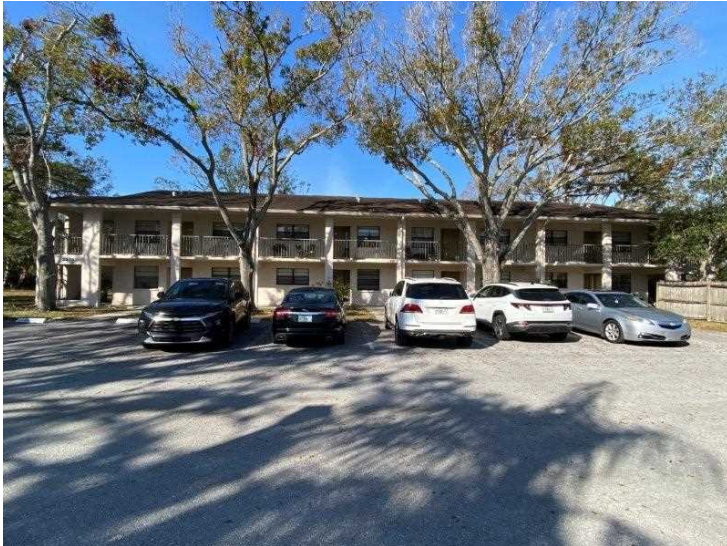
Exterior Elevation

| <b>5. Roof Geometry:</b><br>Comments: | <b>Other Roof</b><br>Inspection verified a gable roof shape. |
| <b>7. Opening Protection:</b><br>Comments: | <b>None or Some Glazed Openings</b><br>At the time of inspection no opening protection was verified. |

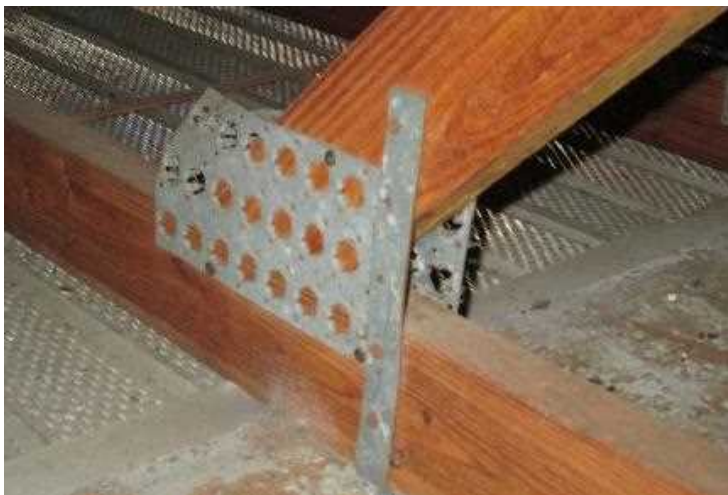
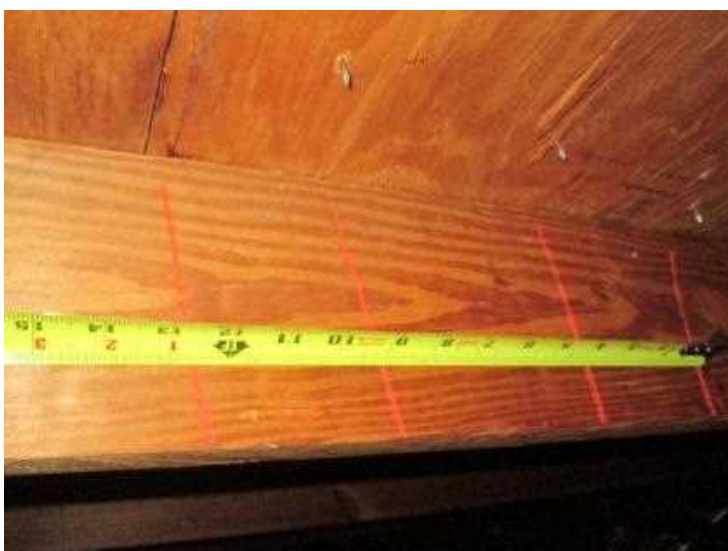
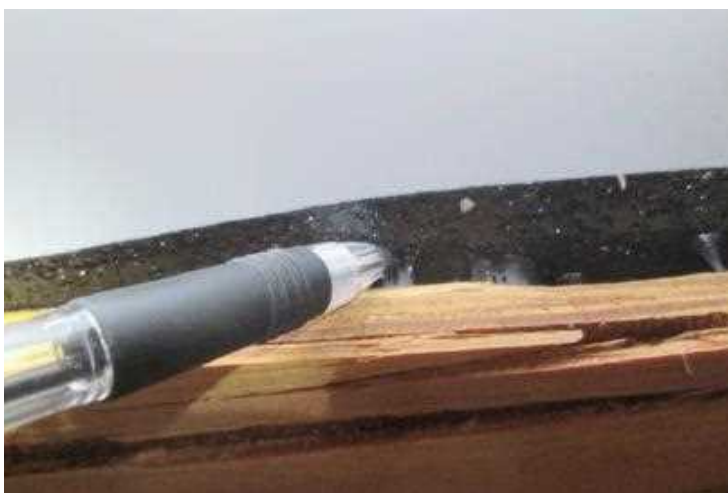
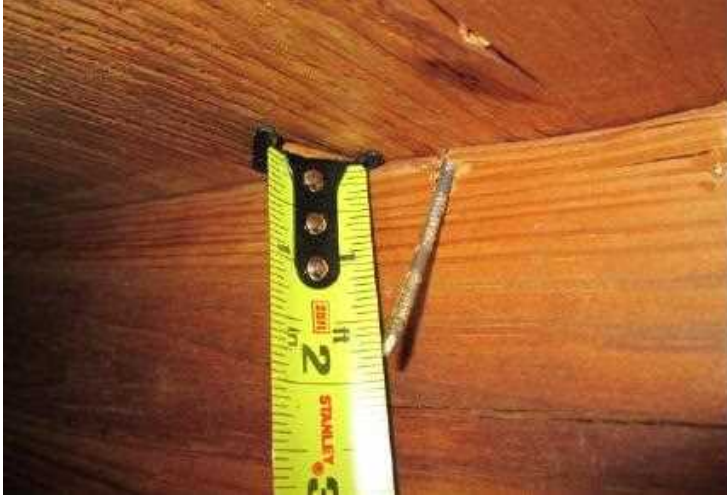
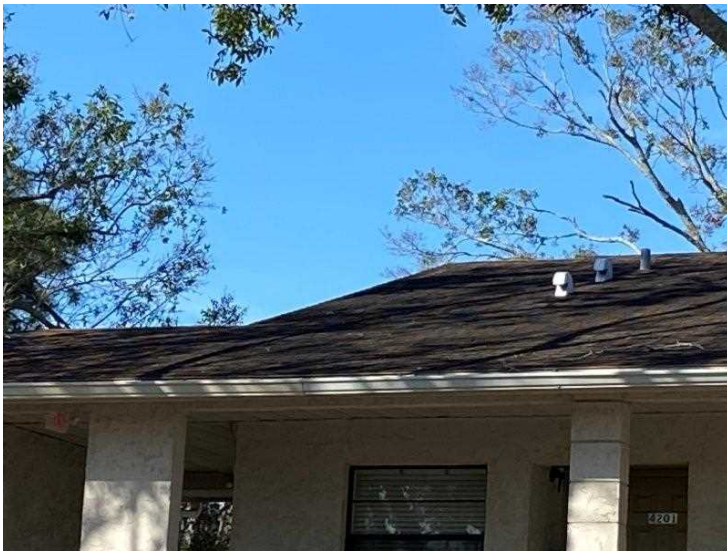
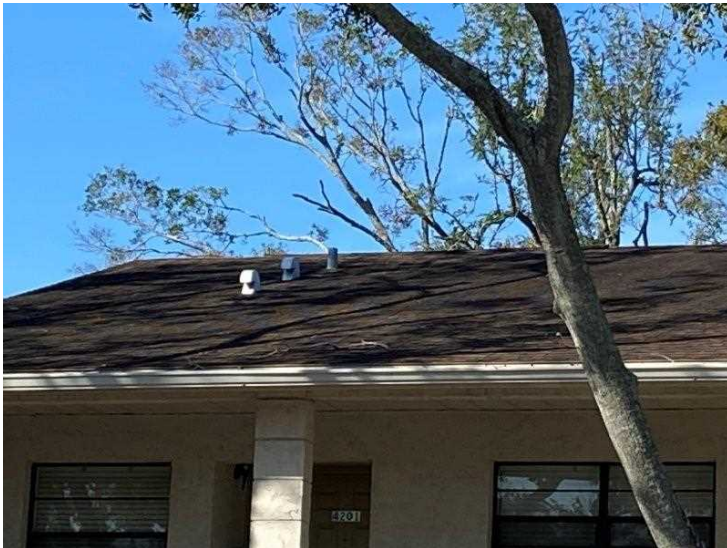
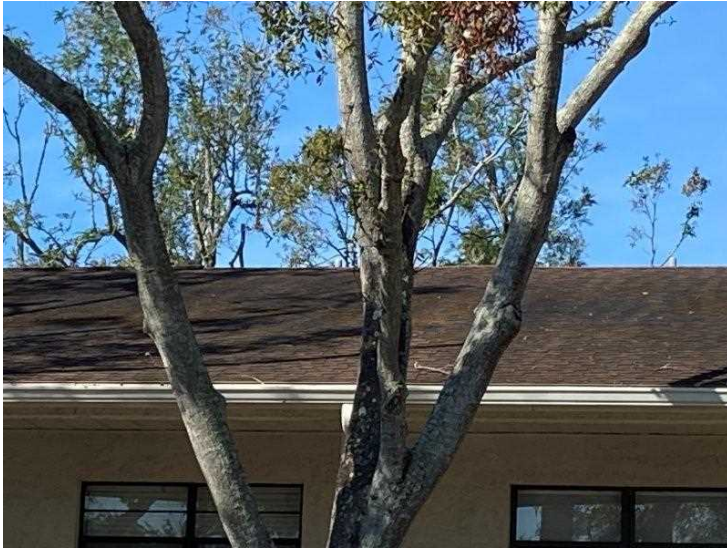
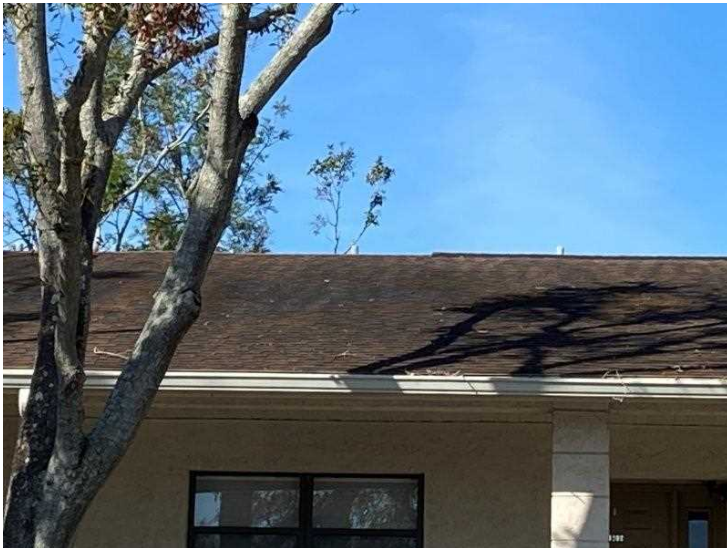
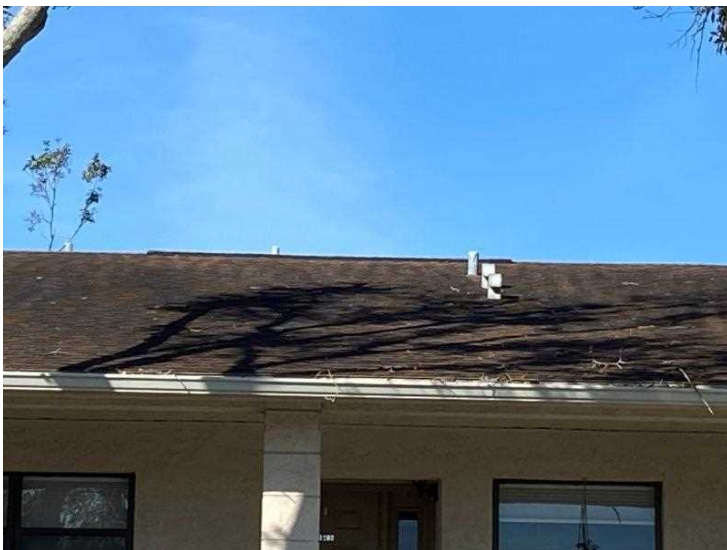
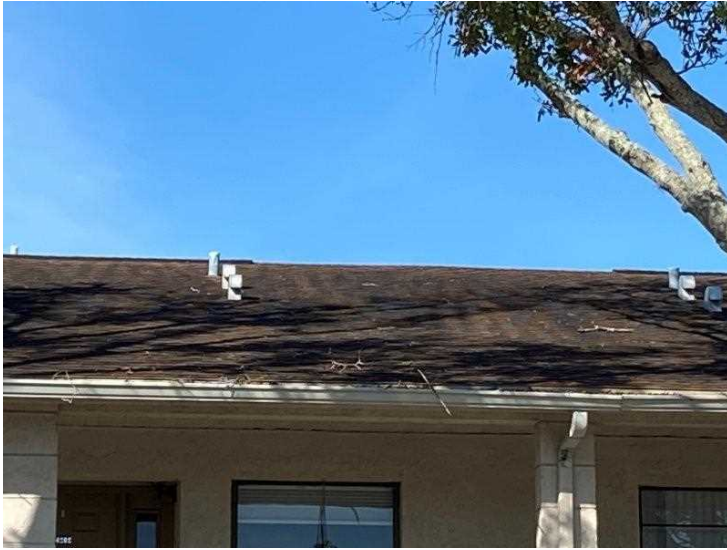
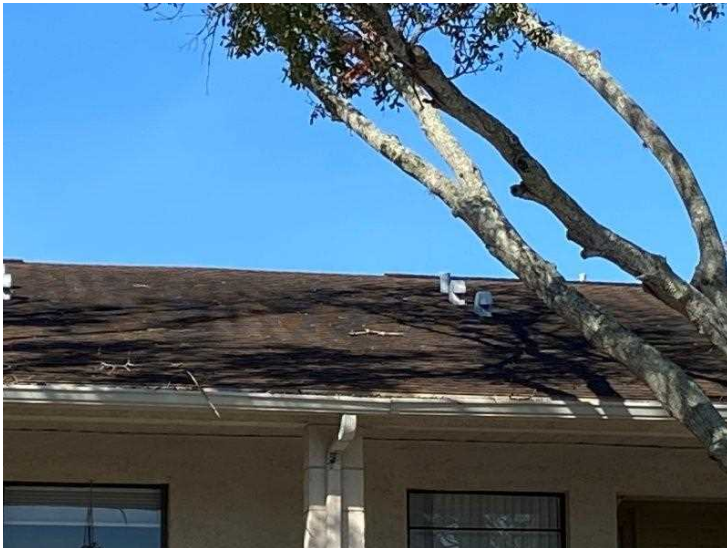
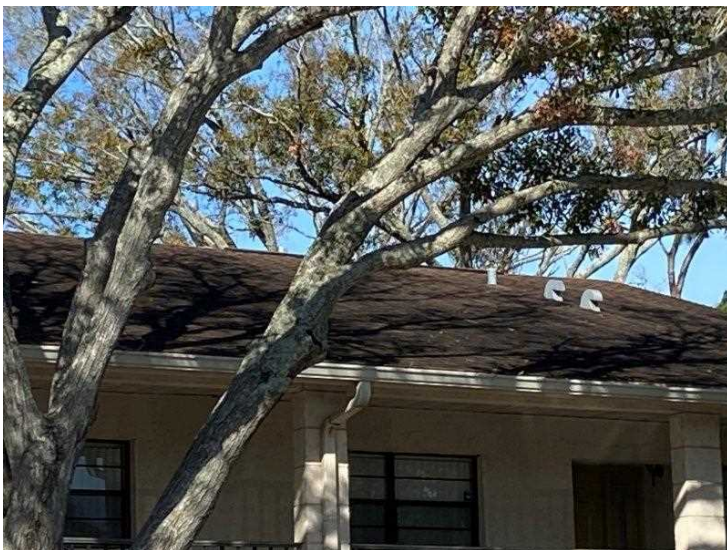
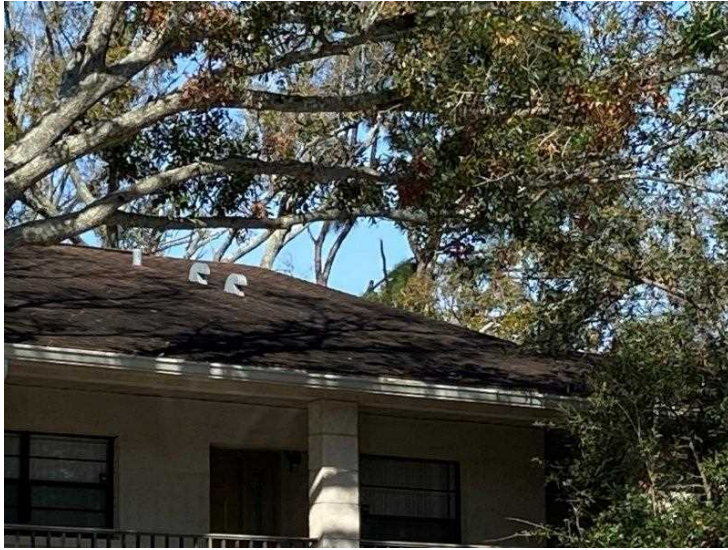
Roof Construction

| <b>3. Roof Deck Attachment:</b><br>Comments: | <b>Level C</b><br>Inspection verified 1/2" plywood roof deck attached with 8d nails at a minimum 6" on the edge & 6" in the field. |
| <b>4. Roof to Wall Attachment:</b><br>Comments: | <b>Clips</b><br>Inspection verified embedded straps fastened with a minimum of three nails. |
| <b>6. SWR:</b><br>Comments: | <b>Yes</b><br>SWR was verified at time of inspection. The Secondary Water Resistance verified is a self-adhering peel and stick. |
