## Windstorm Mitigation Report (OIR-B1-1802)

Chateaux Versailles Condominium Association, Inc.  
2255 62nd Ave N, Clubhouse  
St. Petersburg, FL 33702

As of 02-04-2025 | FPAT File# MUD2523692

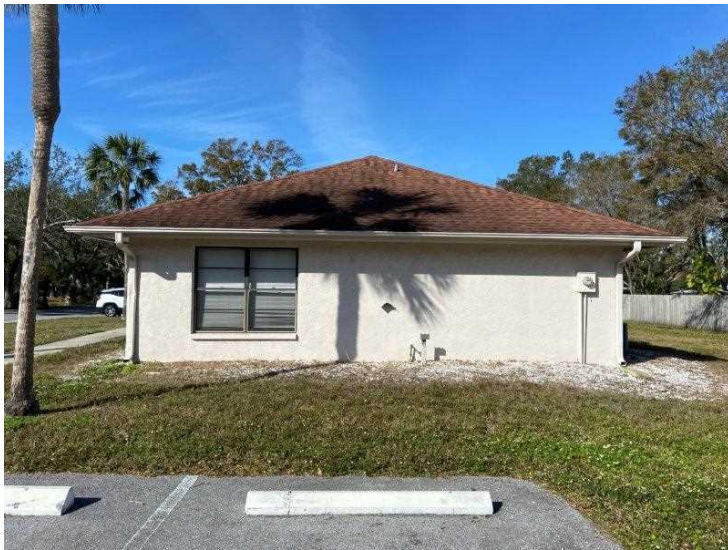
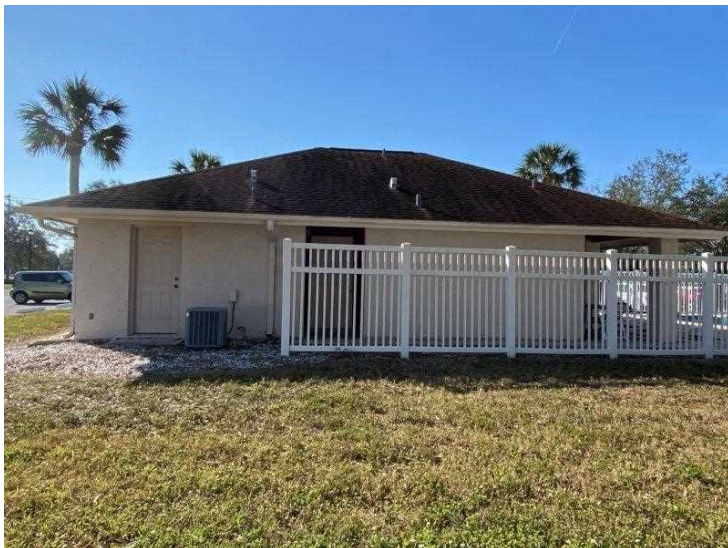
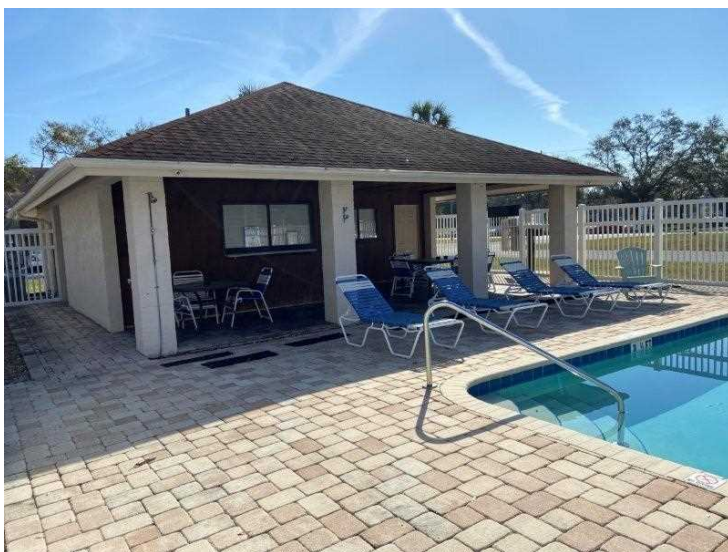
| <b>5. Roof Geometry:</b><br>Comments: | <b>Other Roof</b><br>Inspection verified a gable roof shape. |

Exterior Elevation

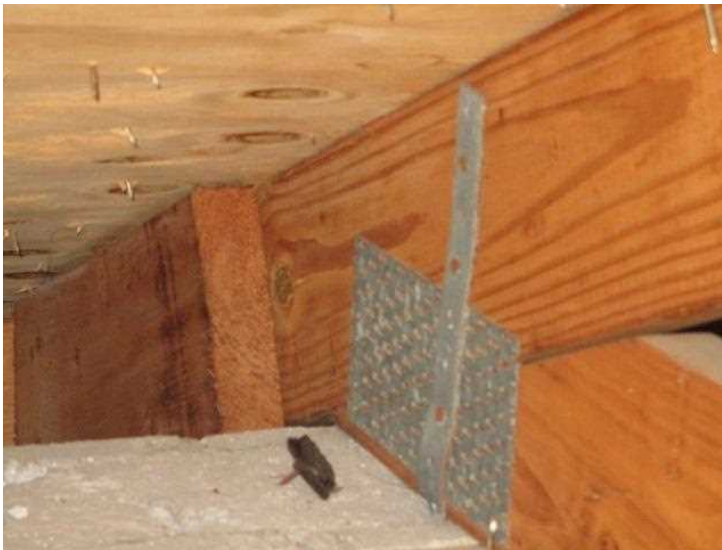
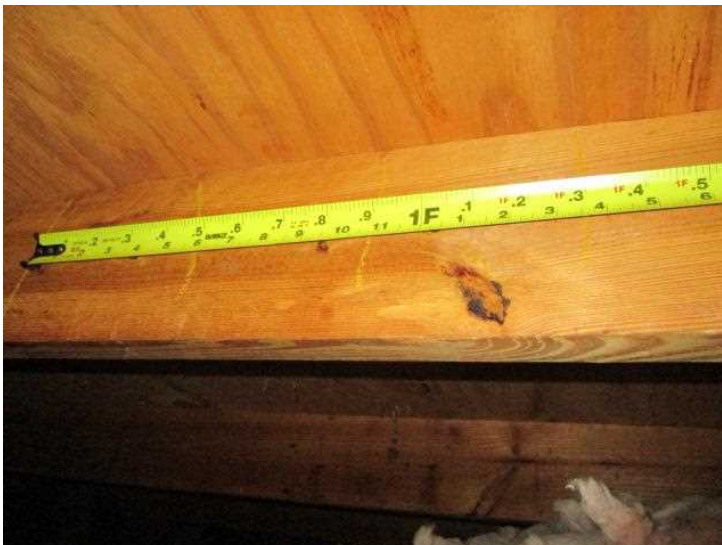
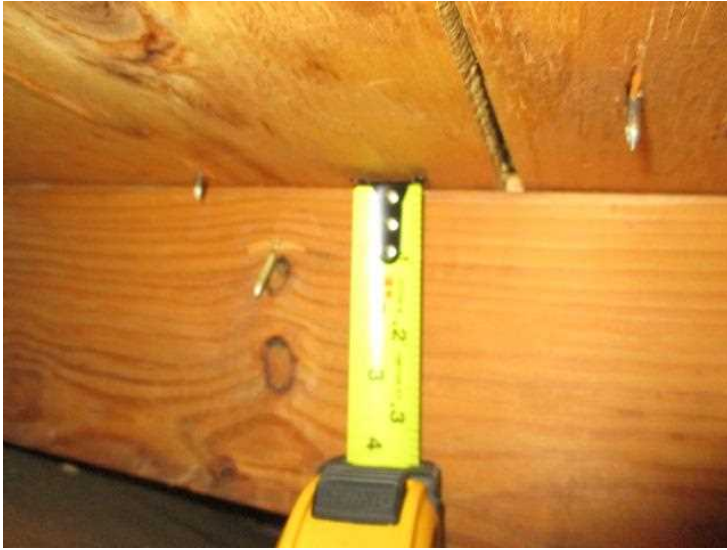
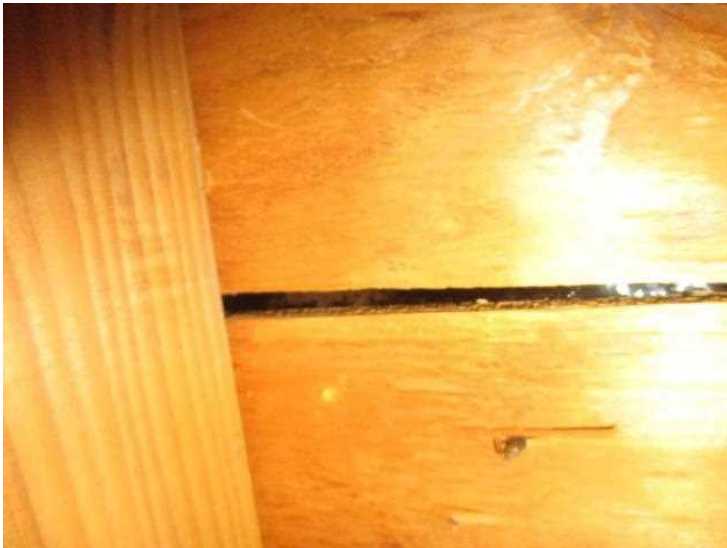
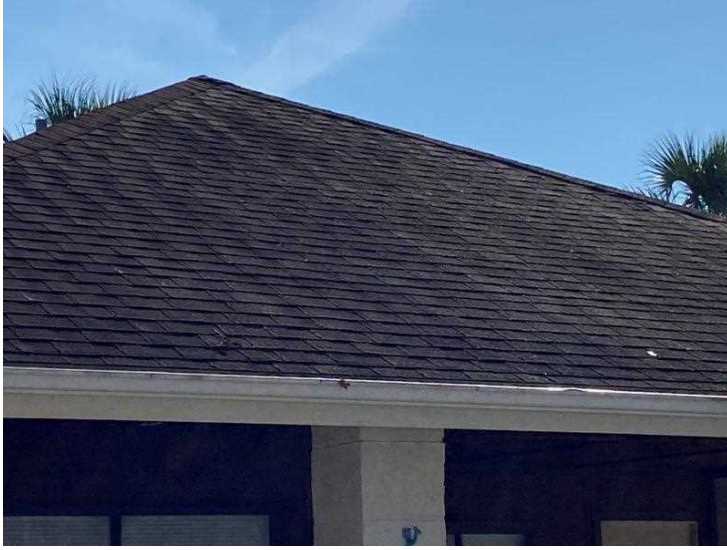
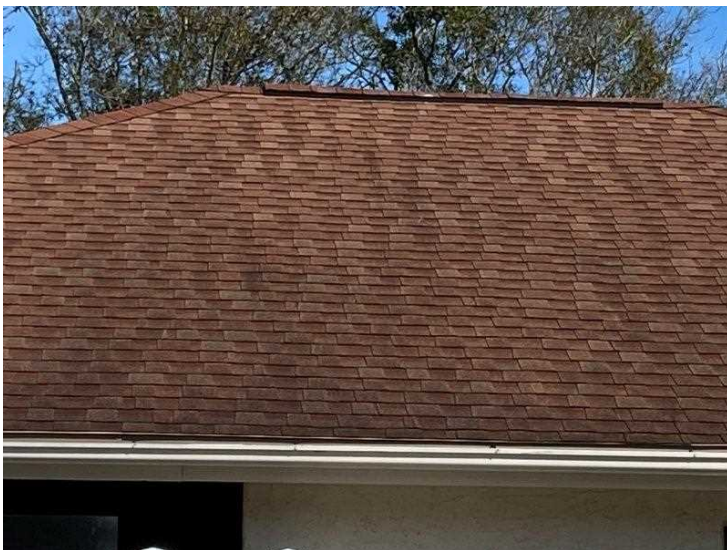
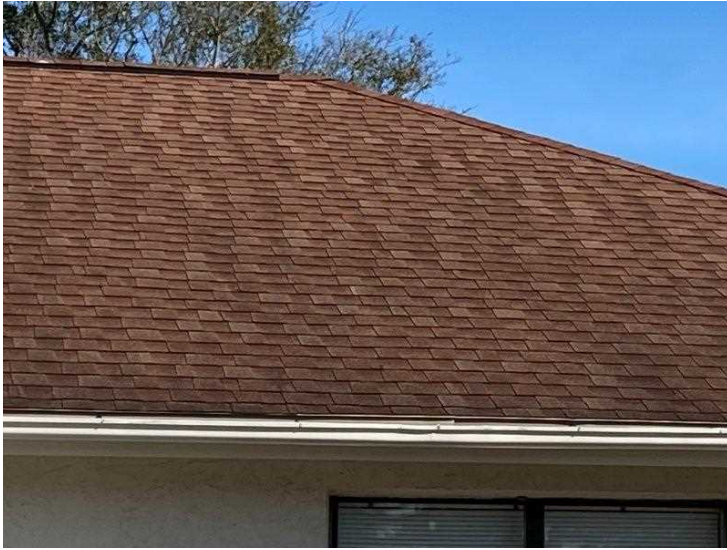
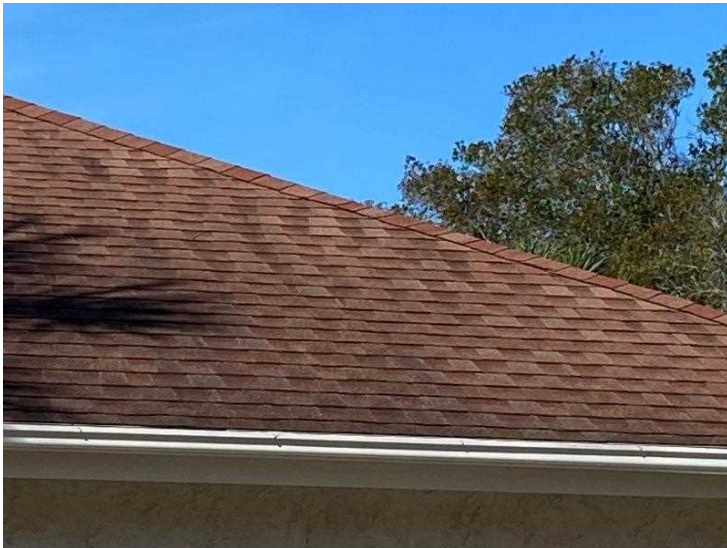
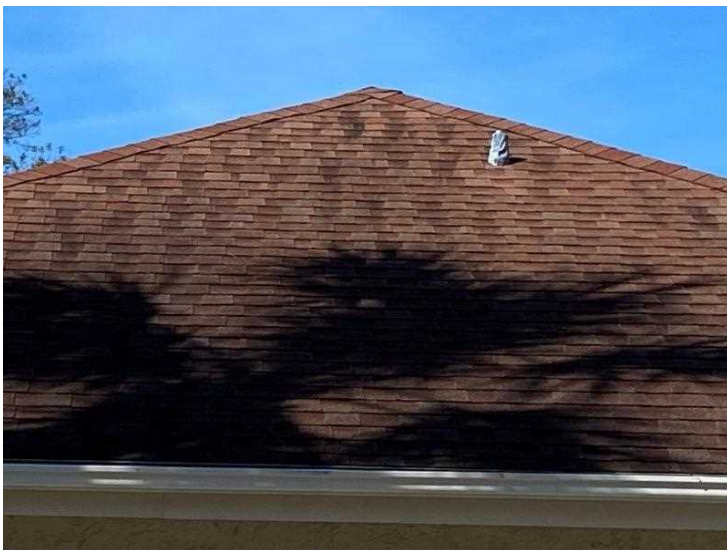
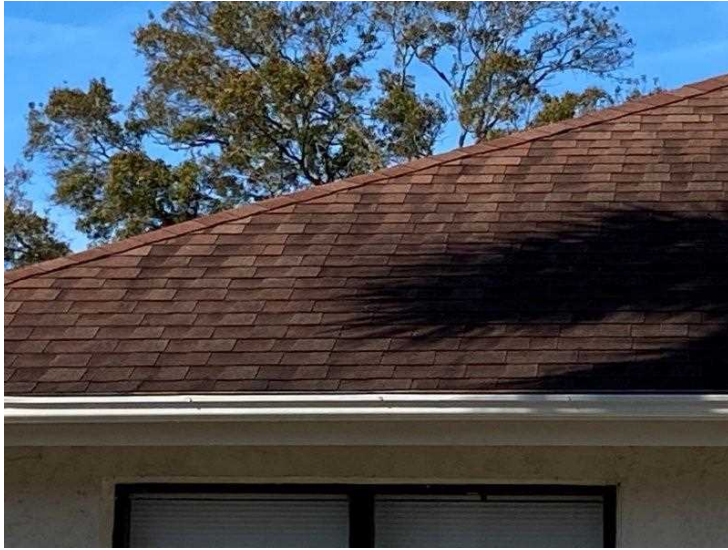
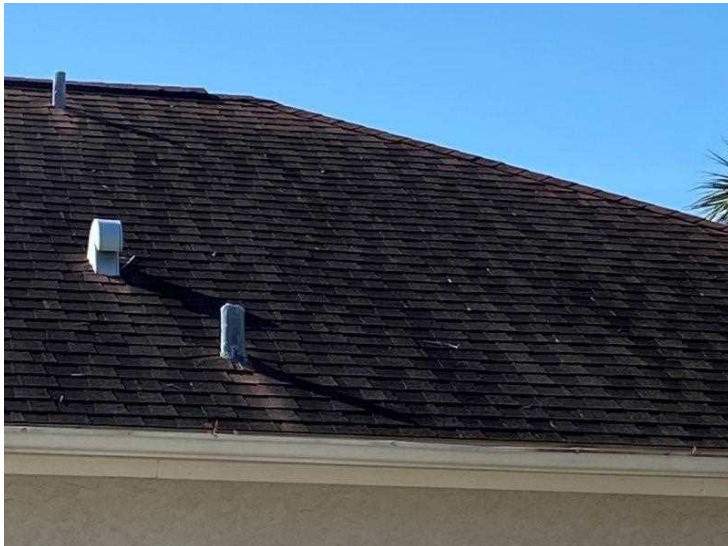
| <b>3. Roof Deck Attachment:</b><br>Comments: | <b>Level C</b><br>Inspection verified 1/2" plywood roof deck attached with 8d nails at a minimum 6" on the edge & 6" in the field. |
| <b>4. Roof to Wall Attachment:</b><br>Comments: | <b>Clips</b><br>Inspection verified embedded straps fastened with a minimum of three nails. |
| <b>6. SWR:</b><br>Comments: | <b>Yes</b><br>SWR was verified at time of inspection. The Secondary Water Resistance verified is a self-adhering peel and stick. |

### Roof Construction
