## Windstorm Mitigation Report (OIR-B1-1802)

Chateaux Versailles Condominium Association, Inc.

2275 62nd Ave N, Building 5, Units 101-204

As of 02-04-2025 | FPAT File# MUD2523692

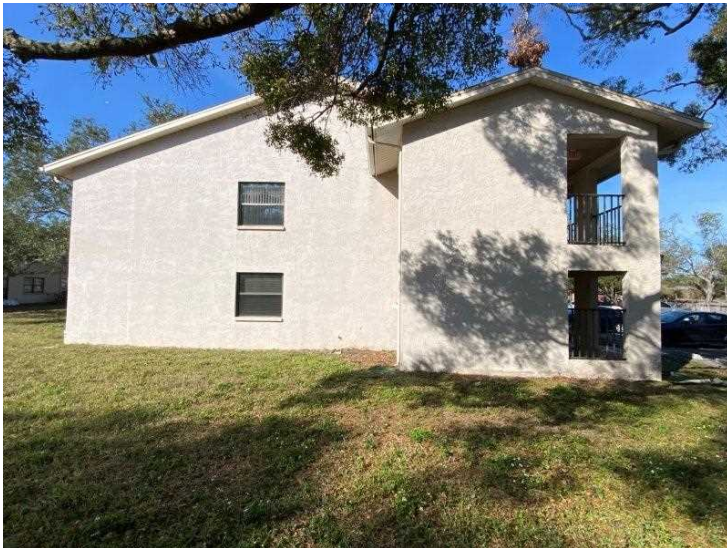
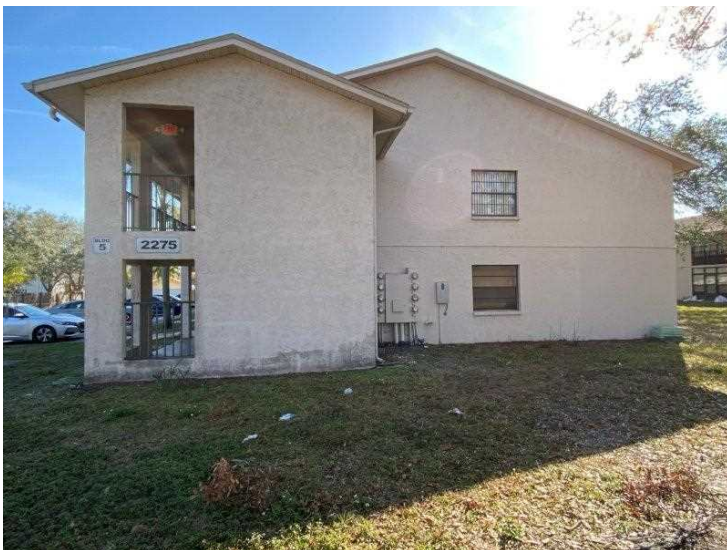
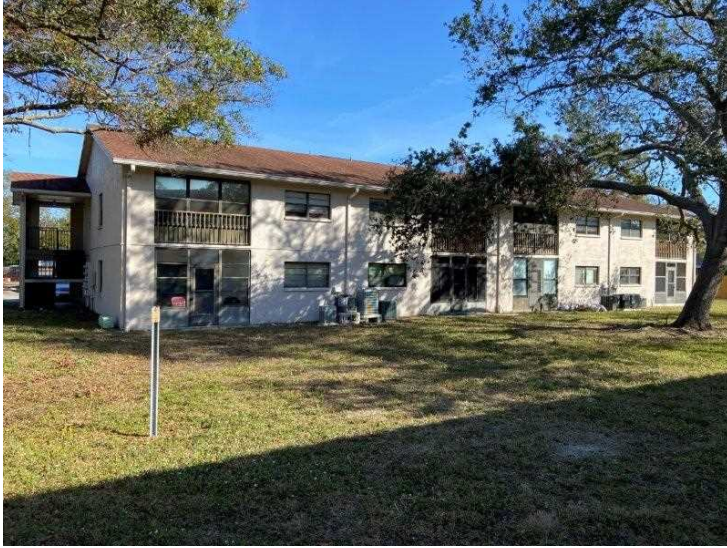
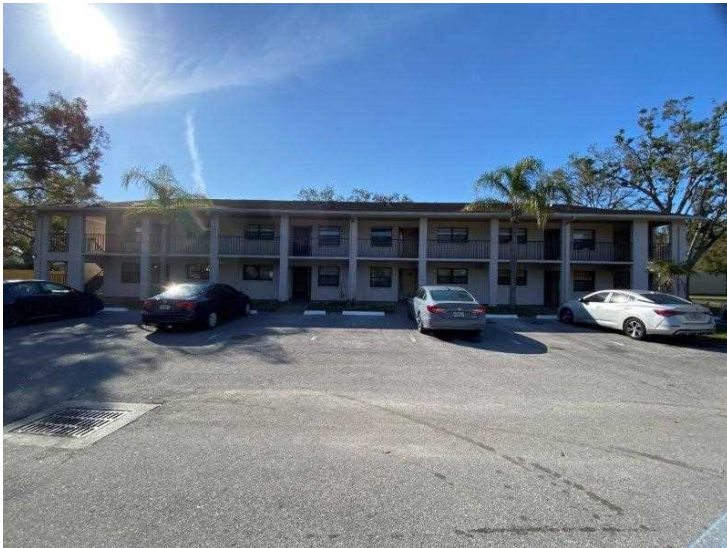
Exterior Elevation

| <b>5. Roof Geometry:</b><br>Comments: | <b>Other Roof</b><br>Inspection verified a gable roof shape. |
| <b>7. Opening Protection:</b><br>Comments: | <b>None or Some Glazed Openings</b><br>At the time of inspection no opening protection was verified. |

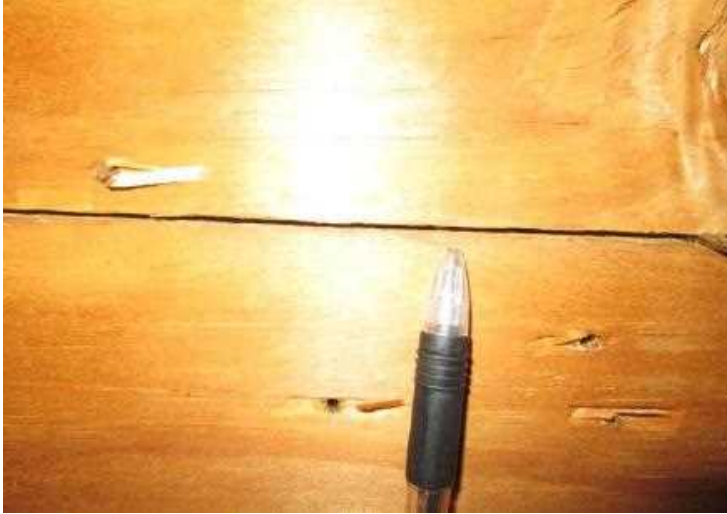
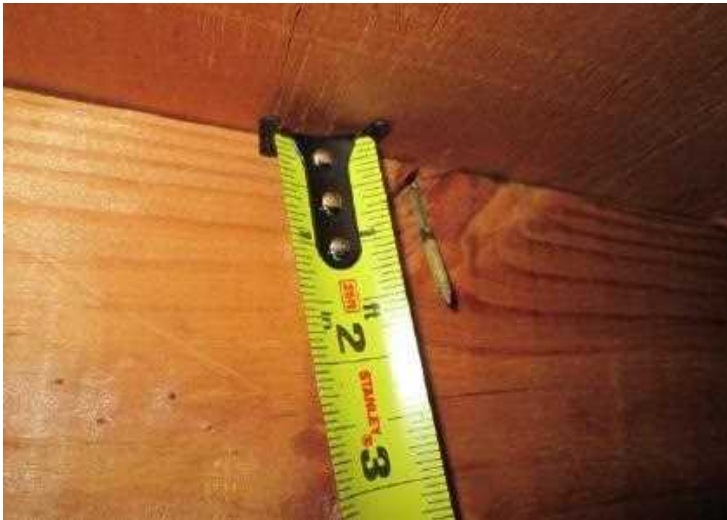
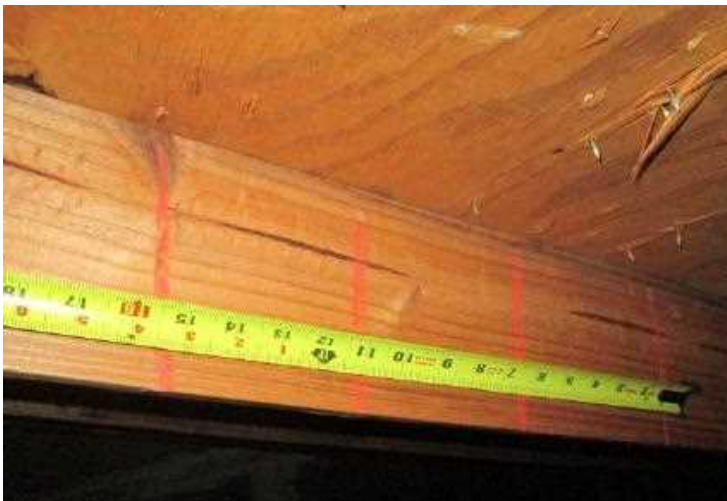
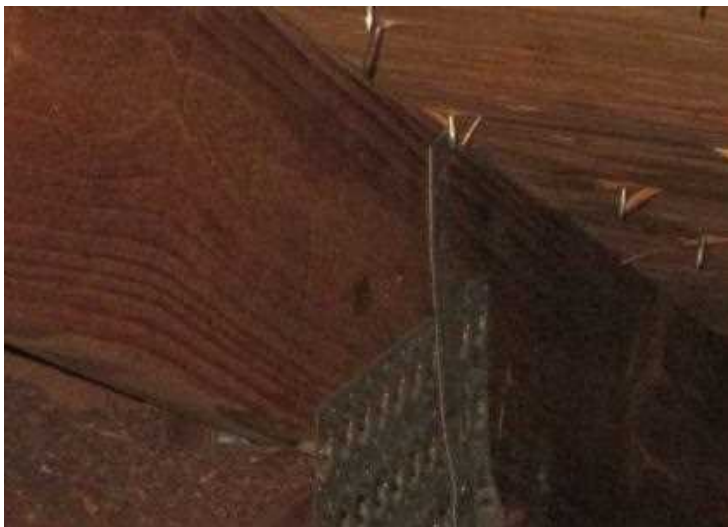
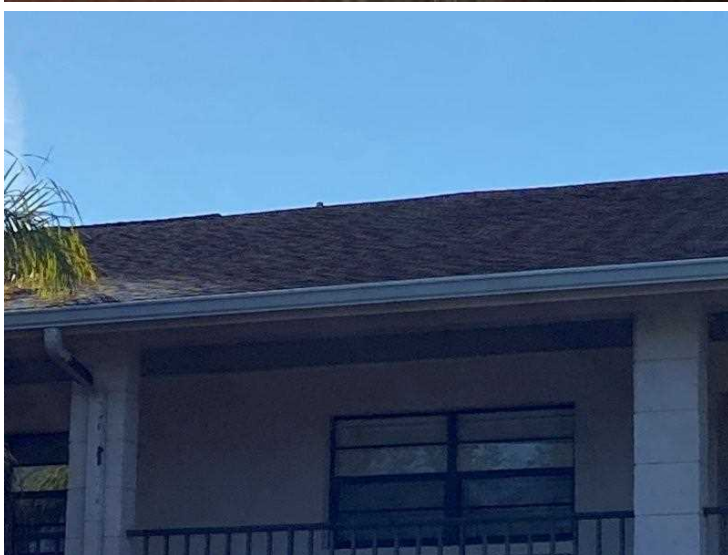
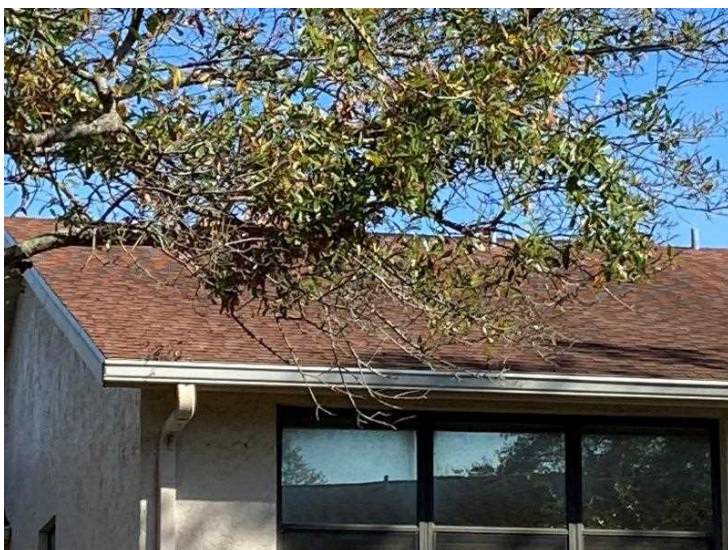
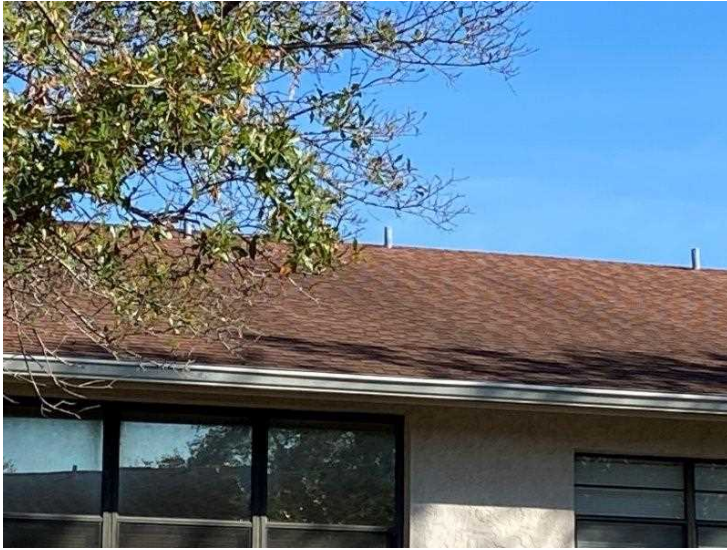
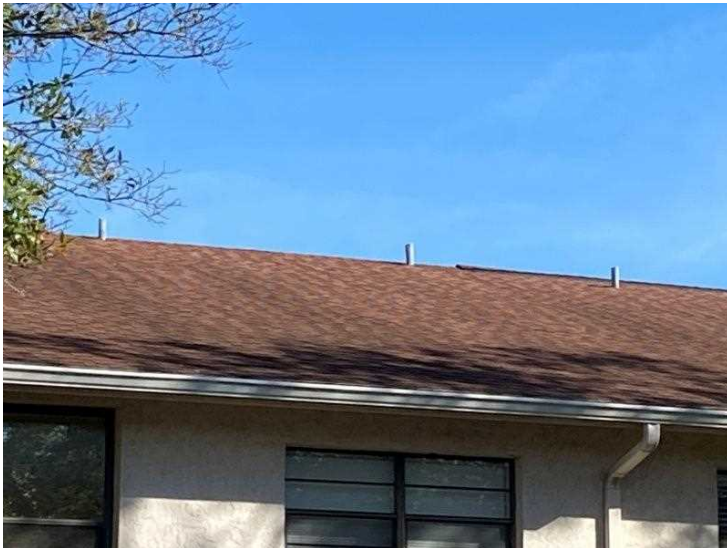
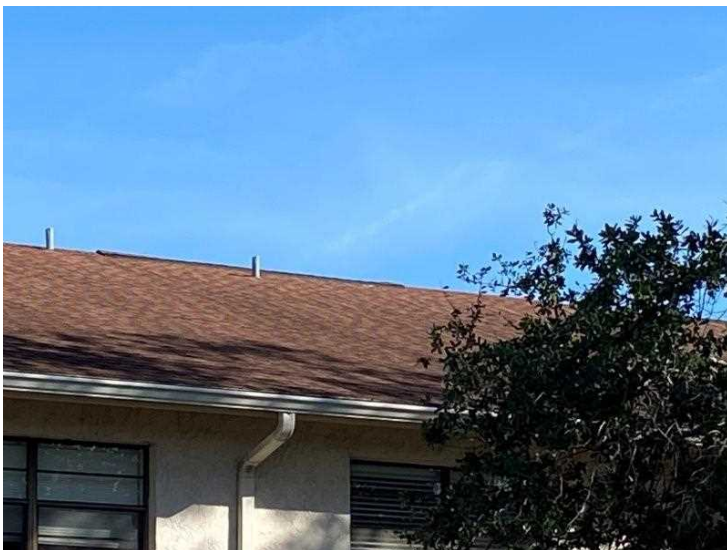
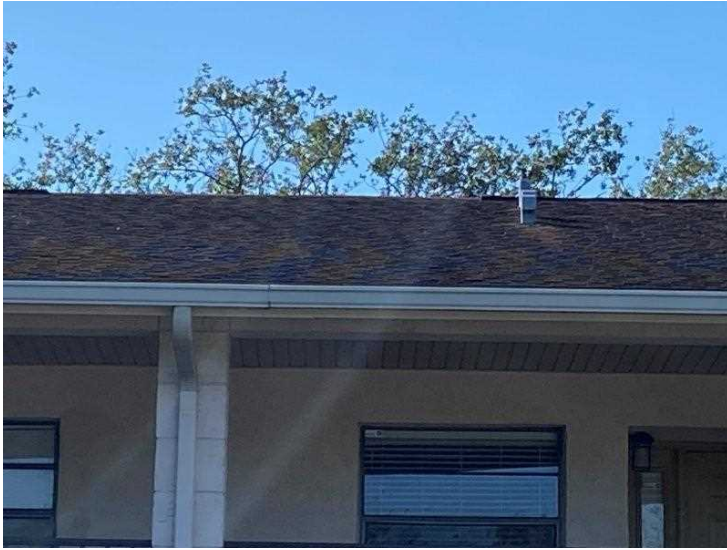
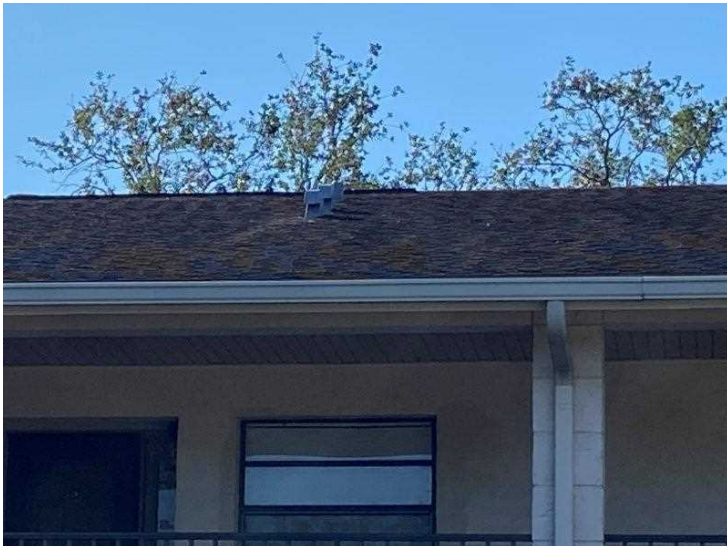
Roof Construction

| <b>3. Roof Deck Attachment:</b><br>Comments: | <b>Level C</b><br>Inspection verified 1/2" plywood roof deck attached with 8d nails at a minimum 6" on the edge & 6" in the field. |
| <b>4. Roof to Wall Attachment:</b><br>Comments: | <b>Clips</b><br>Inspection verified embedded straps fastened with a minimum of three nails. |
| <b>6. SWR:</b><br>Comments: | <b>Yes</b><br>SWR was verified at time of inspection. The Secondary Water Resistance verified is a self-adhering peel and stick. |
