## Windstorm Mitigation Report (OIR-B1-1802)

Chateaux Versailles Condominium Association, Inc.

2225 62nd Ave N, Building 3, Units 3101-3204

As of 02-04-2025 | FPAT File# MUD2523692

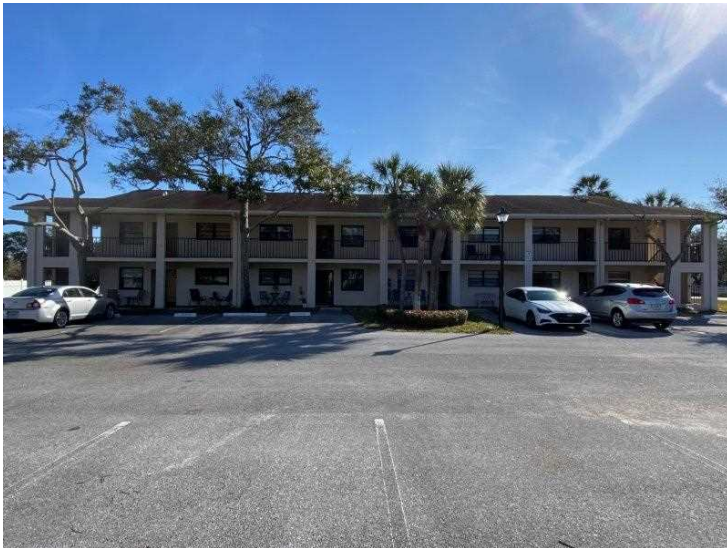
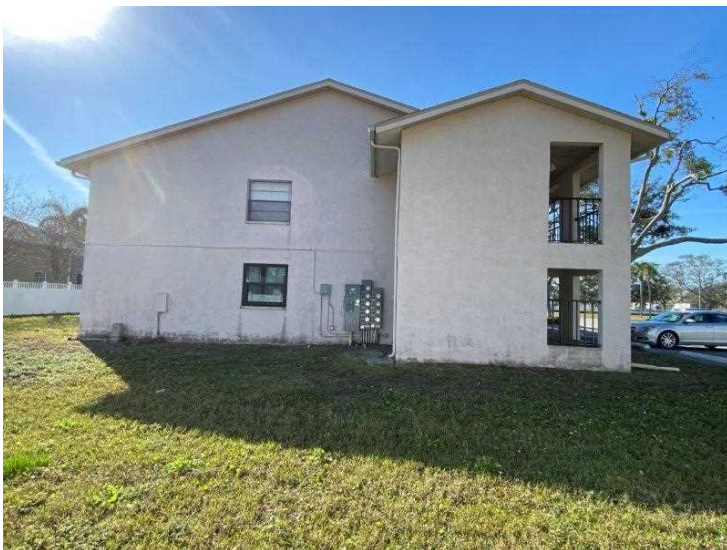
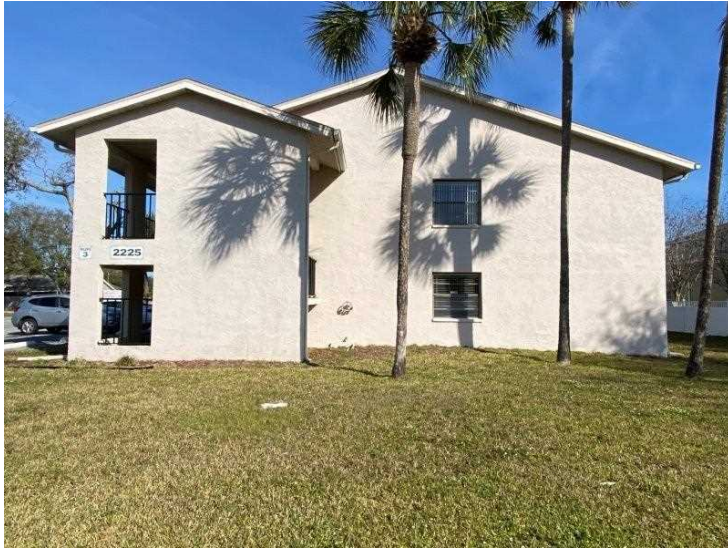
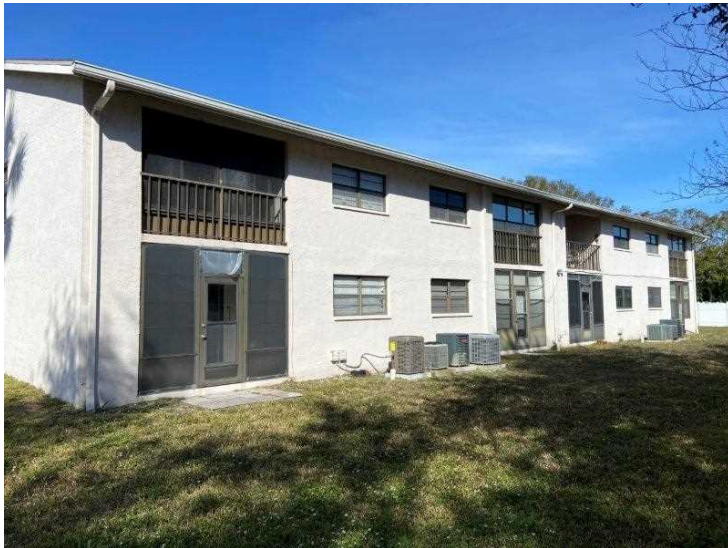
Exterior Elevation

| <b>5. Roof Geometry:</b><br>Comments: | <b>Other Roof</b><br>Inspection verified a gable roof shape. |
| <b>7. Opening Protection:</b><br>Comments: | <b>None or Some Glazed Openings</b><br>At the time of inspection no opening protection was verified. |

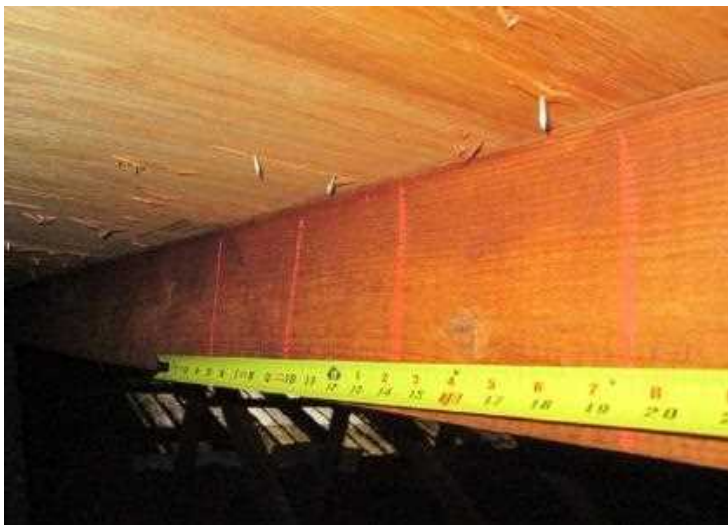
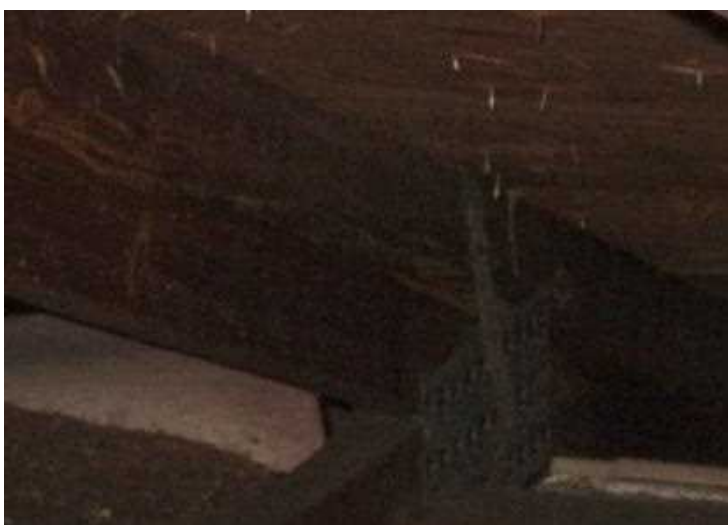
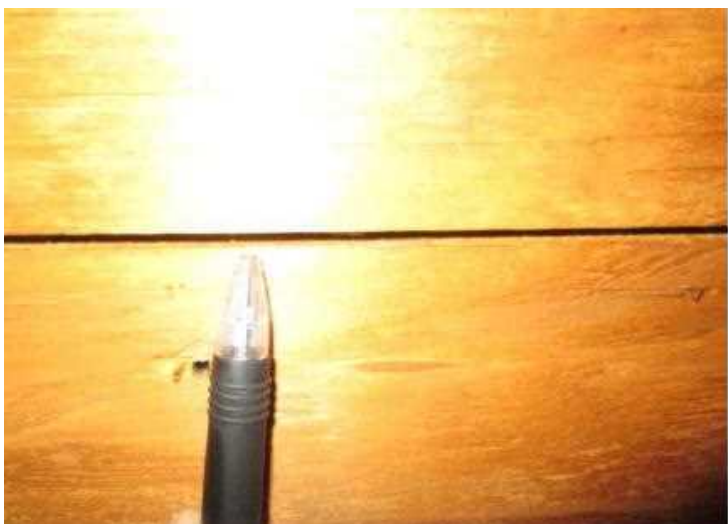
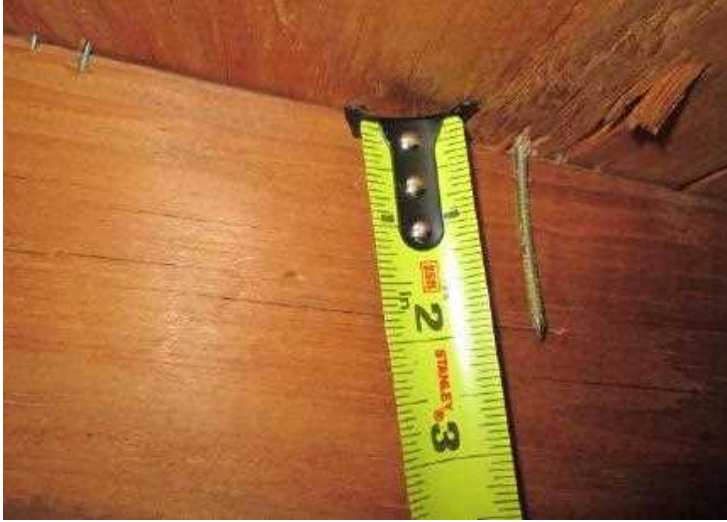
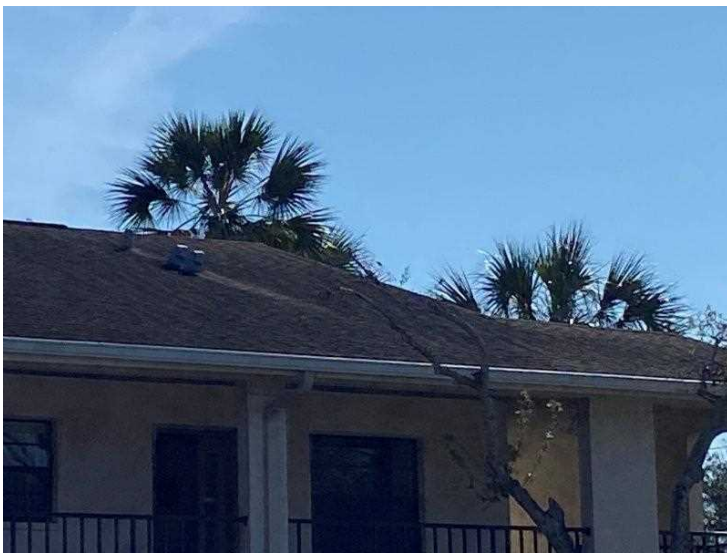
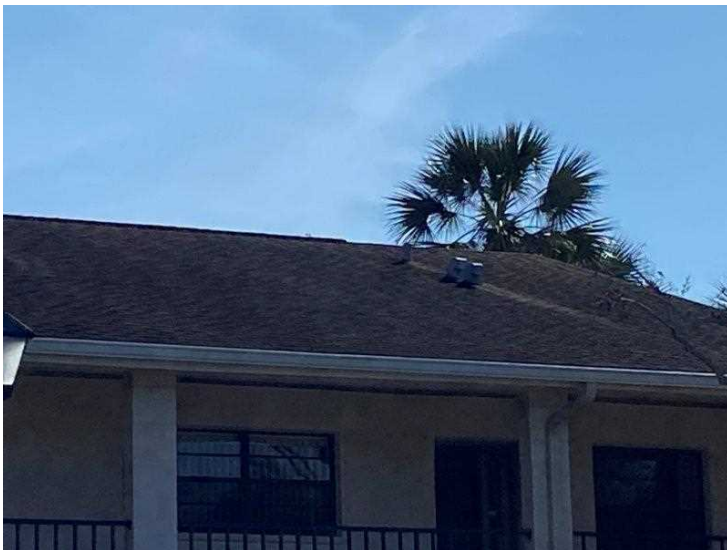
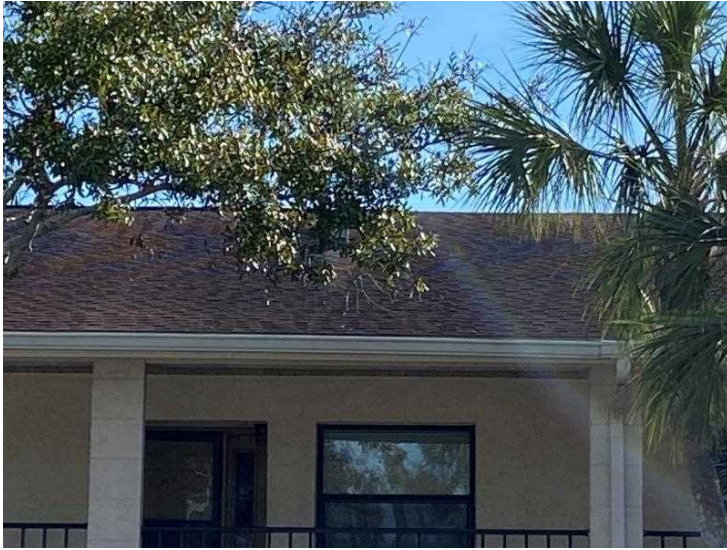
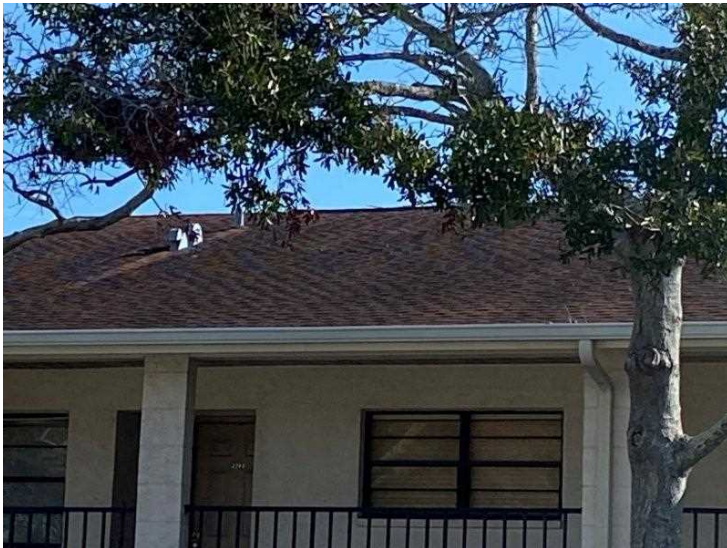
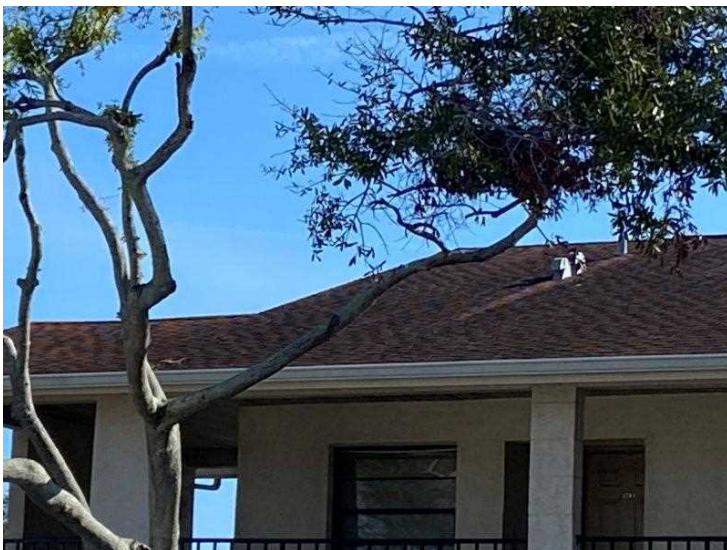
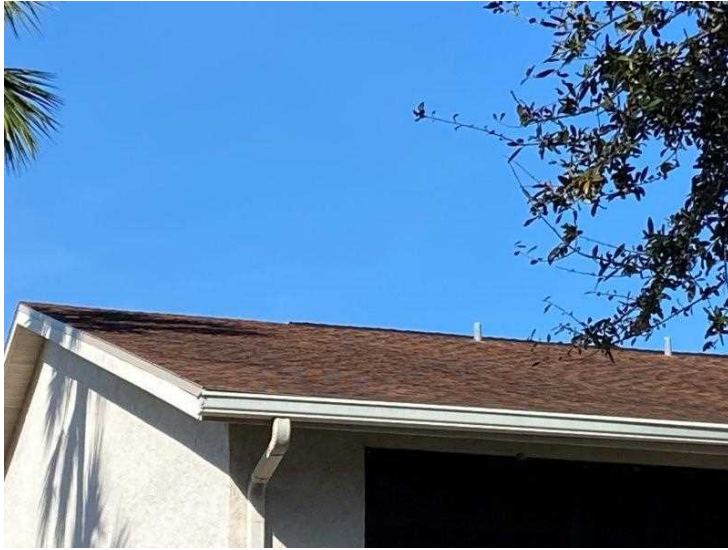
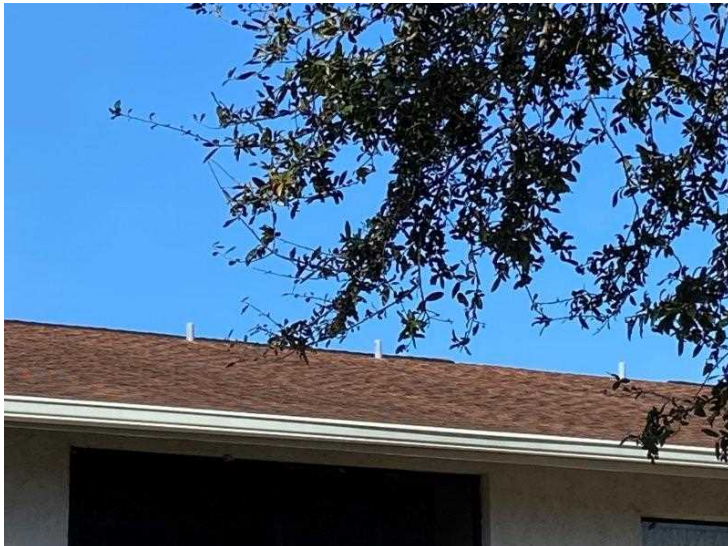
Roof Construction

| <b>3. Roof Deck Attachment:</b><br>Comments: | <b>Level C</b><br>Inspection verified 1/2" plywood roof deck attached with 8d nails at a minimum 6" on the edge & 6" in the field. |
| <b>4. Roof to Wall Attachment:</b><br>Comments: | <b>Clips</b><br>Inspection verified embedded straps fastened with a minimum of three nails. |
| <b>6. SWR:</b><br>Comments: | <b>Yes</b><br>SWR was verified at time of inspection. The Secondary Water Resistance verified is a self-adhering peel and stick. |
