## Windstorm Mitigation Report (OIR-B1-1802)

Chateaux Versailles Condominium Association, Inc.

2255 62nd Ave N, Building 2, Units 2101-2208

As of 02-04-2025 | FPAT File# MUD2523692

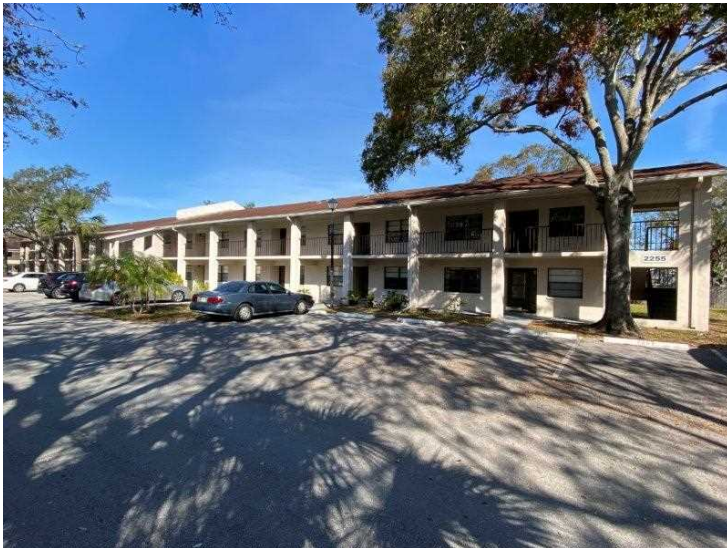
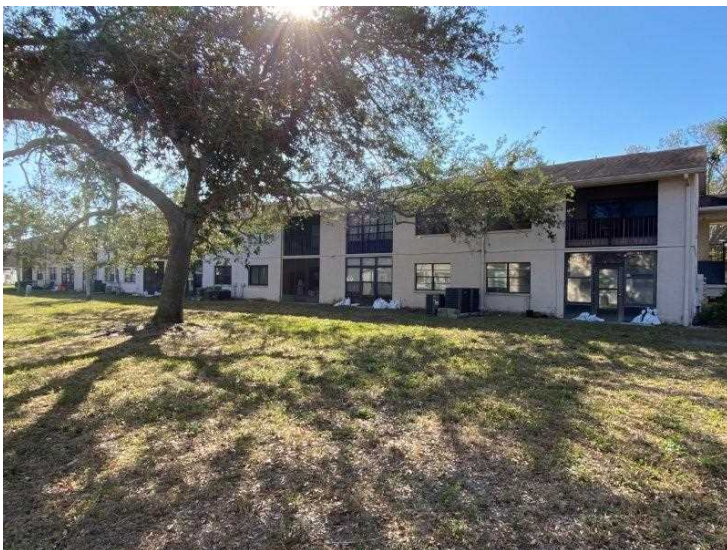
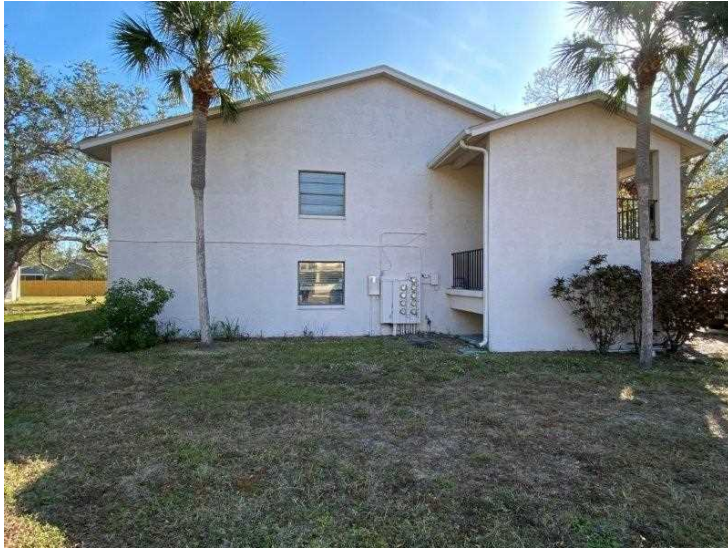
Exterior Elevation

| <b>5. Roof Geometry:</b><br>Comments: | <b>Other Roof</b><br>Inspection verified a gable roof shape. |

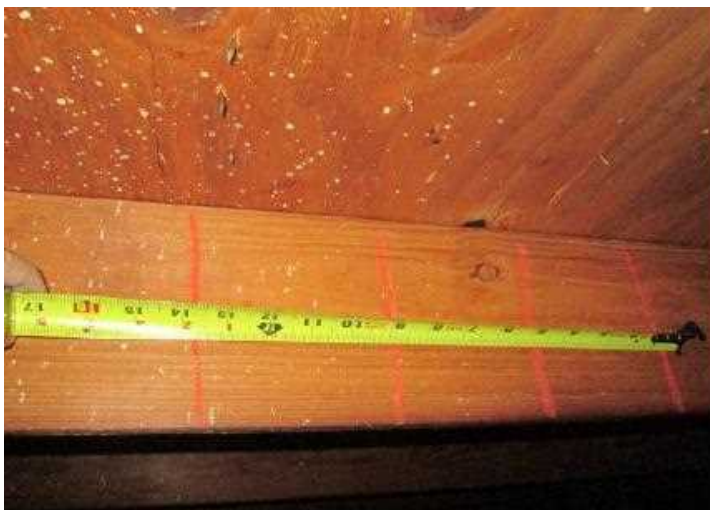
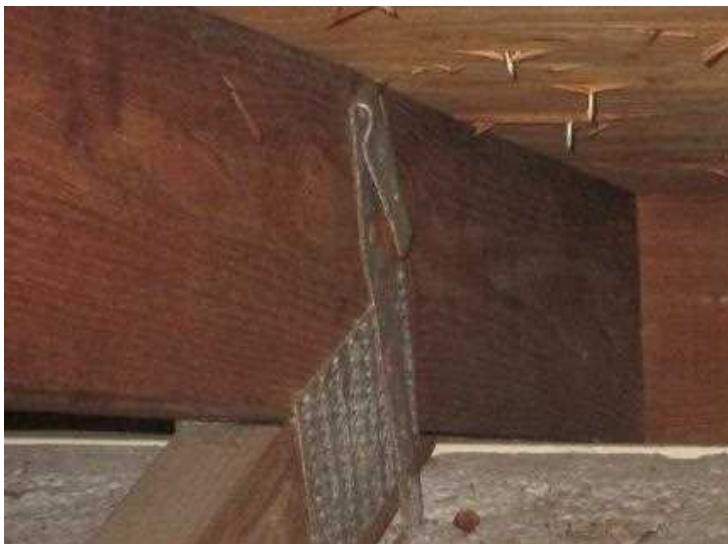
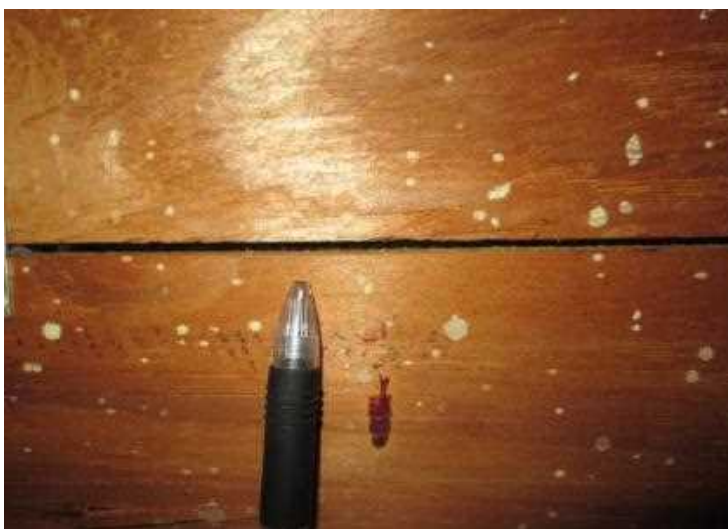
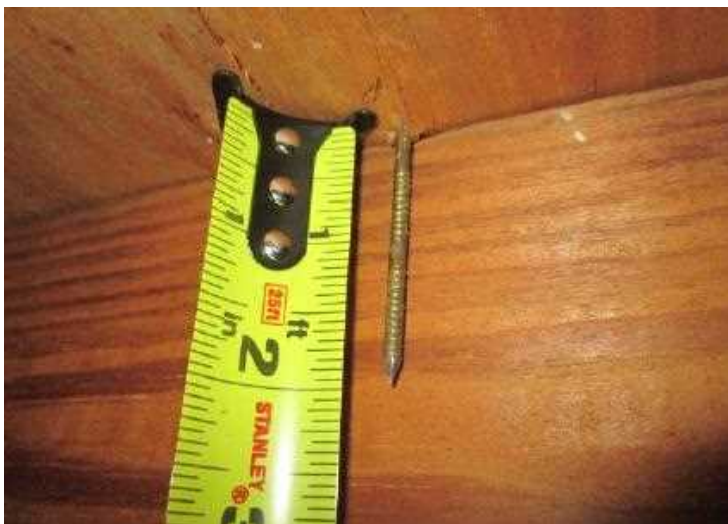
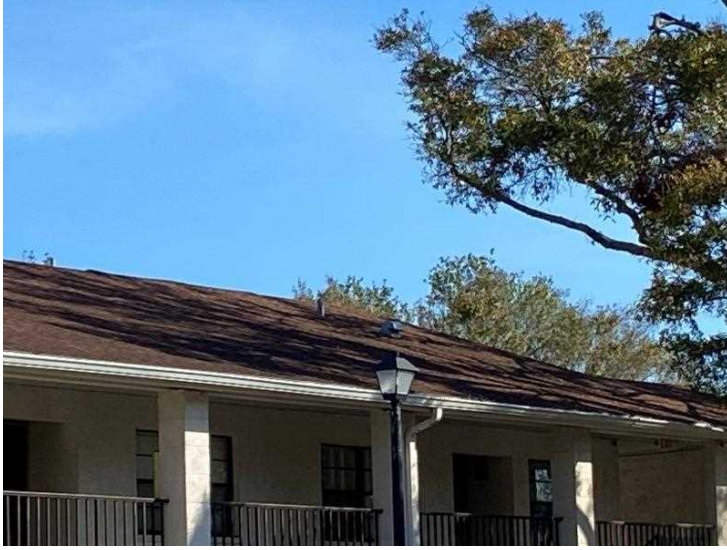
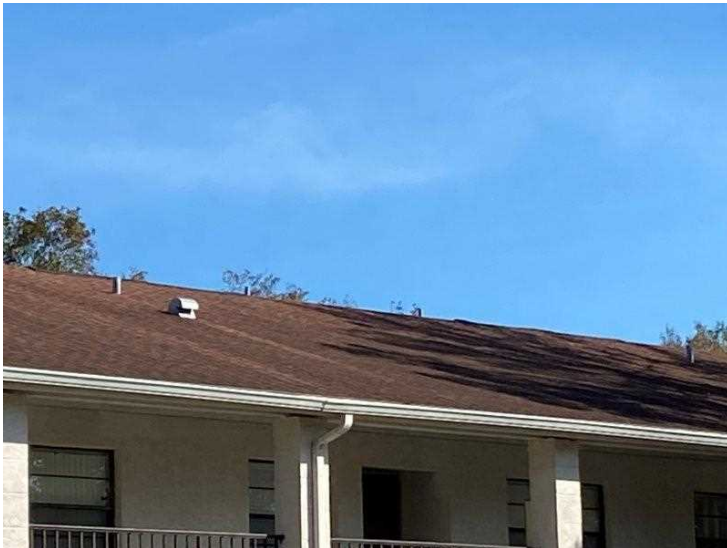
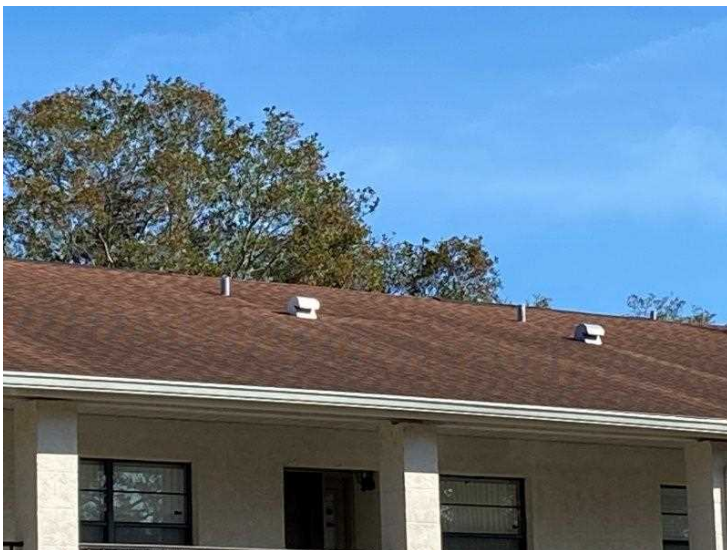
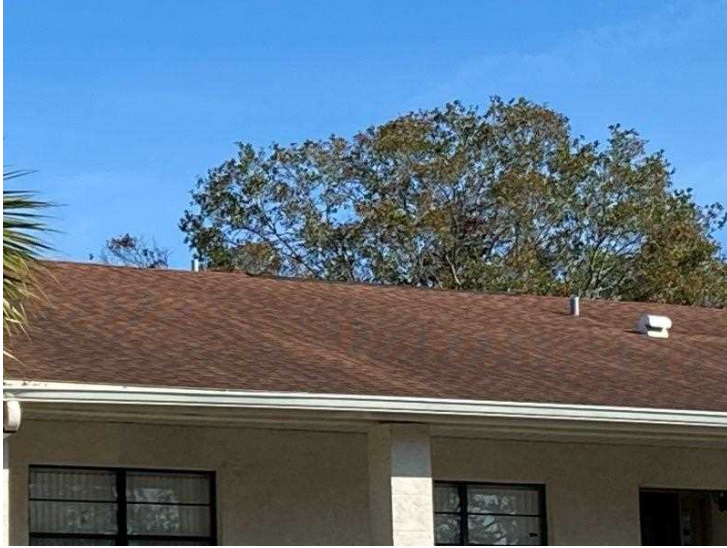
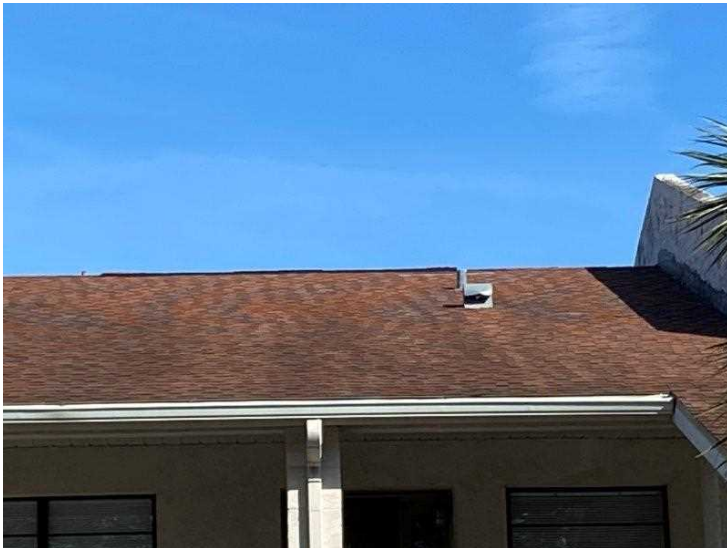
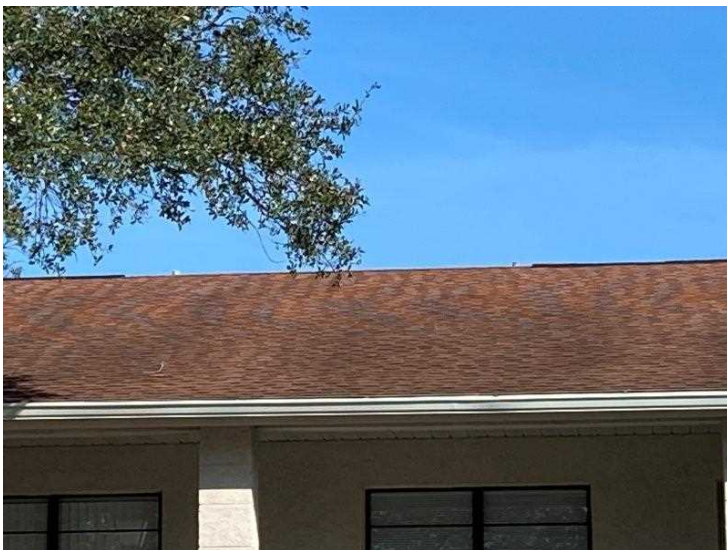
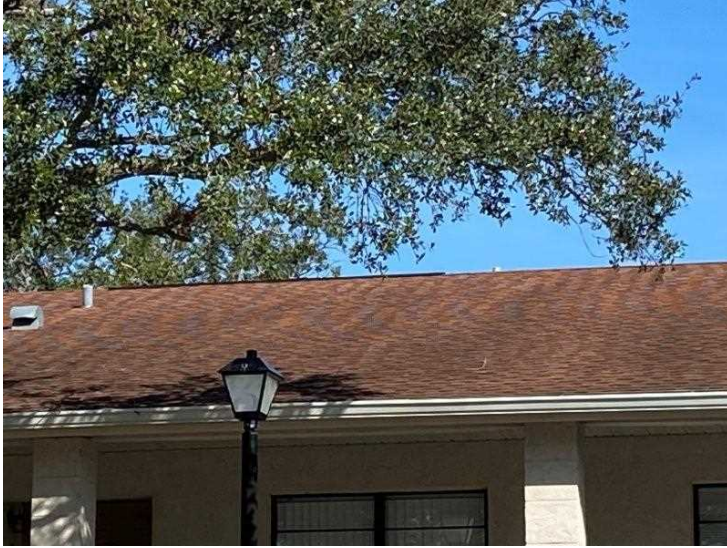
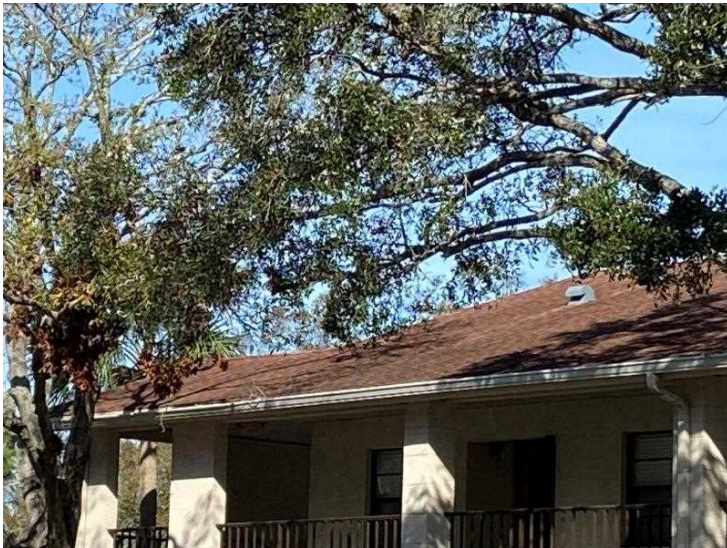
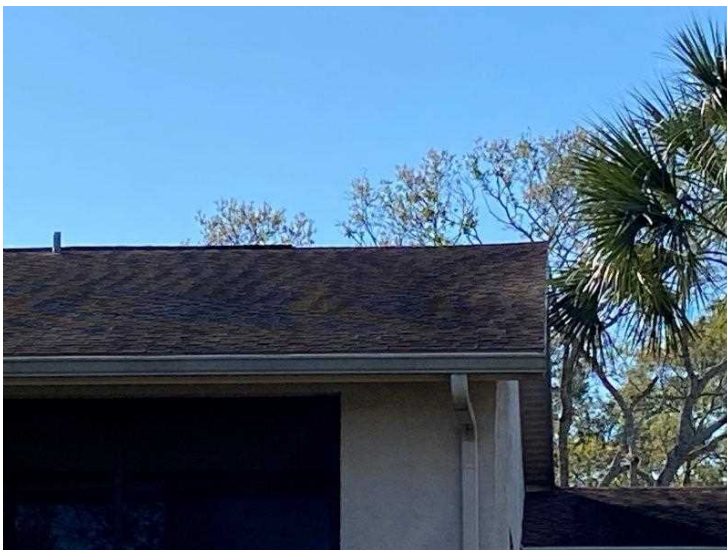
Roof Construction

| <b>3. Roof Deck Attachment:</b><br>Comments: | <b>Level C</b><br>Inspection verified 1/2" plywood roof deck attached with 8d nails at a minimum 6" on the edge & 6" in the field. |
| <b>4. Roof to Wall Attachment:</b><br>Comments: | <b>Clips</b><br>Inspection verified embedded straps fastened with a minimum of three nails. |
| <b>6. SWR:</b><br>Comments: | <b>Yes</b><br>SWR was verified at time of inspection. The Secondary Water Resistance verified is a self-adhering peel and stick. |
